# Safety Inspection Report

Annual Inspection

## Station Road Skatepark

24 June 2019

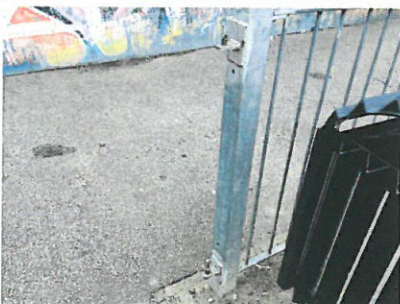
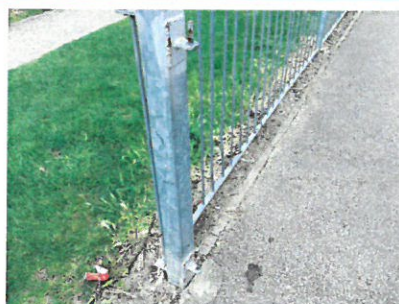
Hard or sharp projections.

Two end posts have gate fittings projecting - remove.

Low

7

Remove hard, pointed and sharp projections.

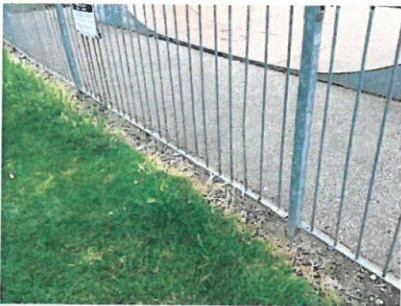
The supports are loose in the ground.

Posts loose in the ground - reset.

Low

4

Re-set.

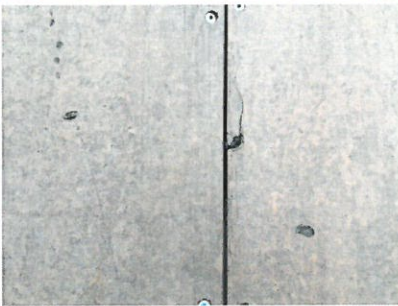
Some damage to the Skatelite riding surface - monitor.

Low

7

Monitor.

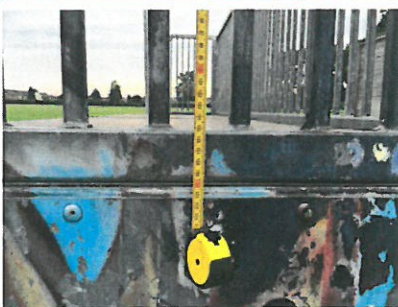
The height of barriers should be at least 1200 mm and should be reached at a maximum distance of 300 mm from the front of the barrier.

Low

7

Refer to manufacturer for comment.

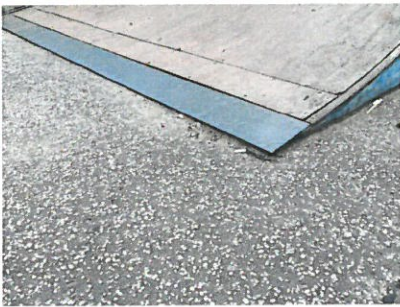
The difference of levels between the ground and the foot should not exceed 5 mm when measured from the top of the foot.

**Medium**

**9**

Modify.

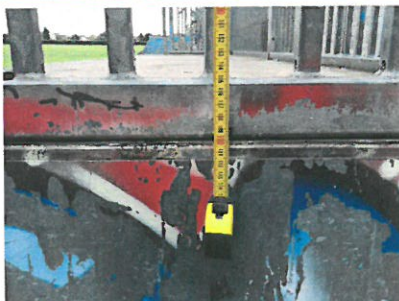
The height of barriers should be at least 1200 mm and should be reached at a maximum distance of 300 mm from the front of the barrier.

Refer to manufacturer for comment.

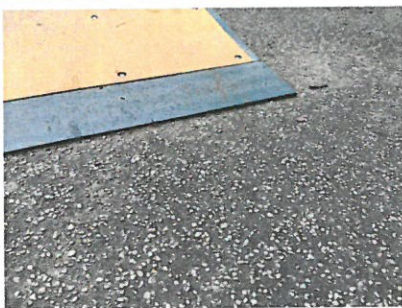
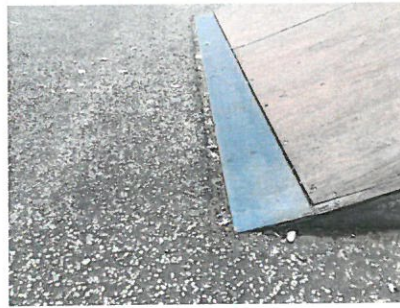
The difference of levels between the ground and the foot should not exceed 5 mm when measured from the top of the foot.

Foot plate sinking into the tarmac. Large ridge - repair.

Medium

9

Modify.

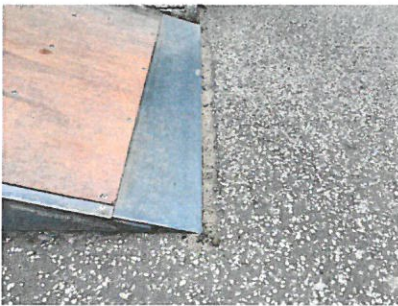
The difference of levels between the ground and the foot should not exceed 5 mm when measured from the top of the foot.

The foot plate is sinking into the tarmac - repair.

High

13

Read the notes for further action.

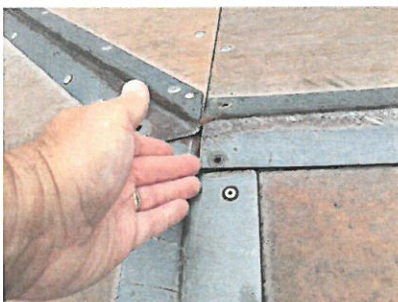
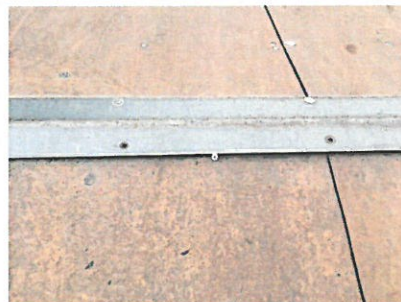
Rivets are missing.

Riding surface metalwork lifting due to damaged rivets - repair.

**Risk level:**  
Medium

**Risk score:**  
10

Replace.

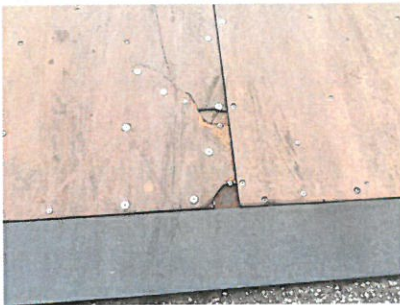
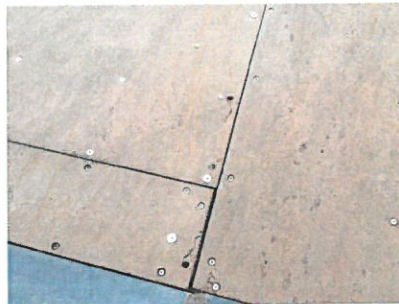
Item is damaged.

Skatelite damaged - replace.

Medium

8

Replace.

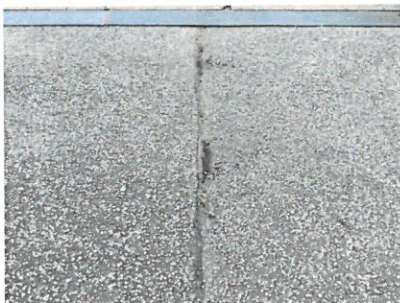
Surface is uneven.

Tarmac uneven - repair.

Low

7

Make good.

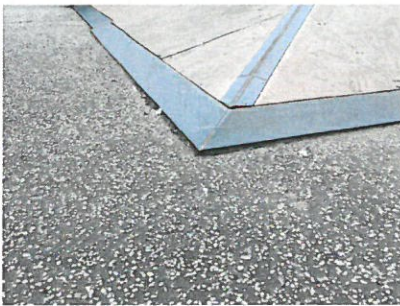
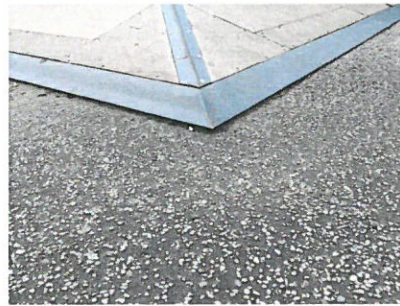
The difference of levels between the ground and the foot should not exceed 5 mm when measured from the top of the foot.

The foot plate is sinking into the tarmac - repair.

**Medium**

**9**

Modify.

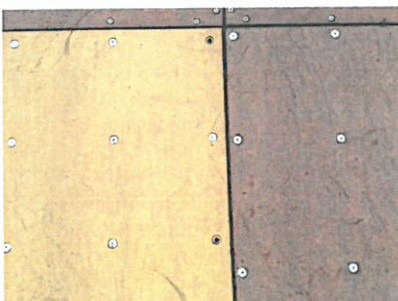
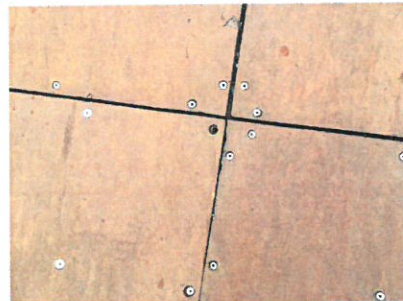
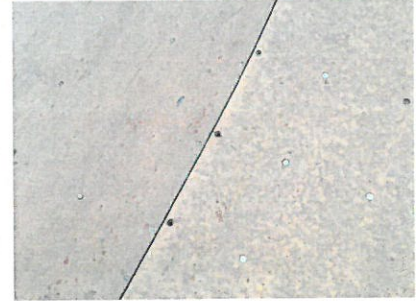
Rivets are missing.

The riding surface is lifting due to damaged rivets - repair.

**Risk level:**  
Medium

**Risk score:**  
10

Replace.

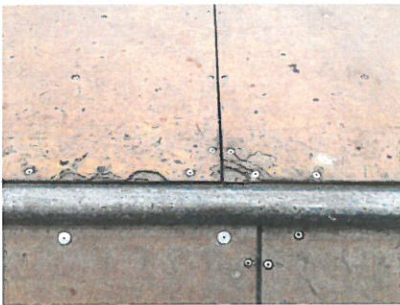
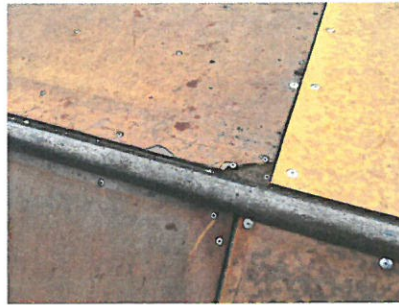
Item edges are worn.

Timber delaminating and damaged.

Low

7

Replace.

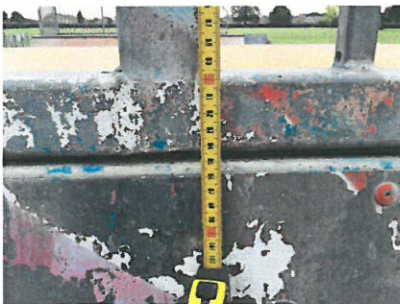
The height of barriers should be at least 1200 mm and should be reached at a maximum distance of 300 mm from the front of the barrier.

Medium

8

Refer to manufacturer for comment.

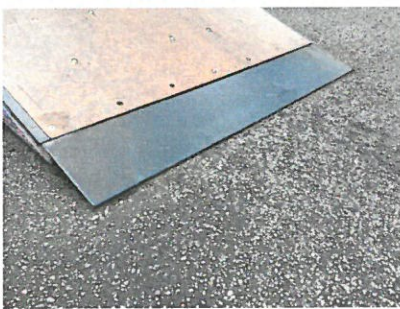
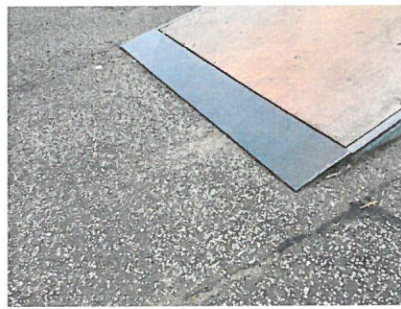
The difference of levels between the ground and the foot should not exceed 5 mm when measured from the top of the foot.

The foot plate is sinking into the tarmac - repair.

**Medium**

**8**

Modify.
