Safety Inspection Report

Post-installation Inspection

Connaught Park

11 January 2023

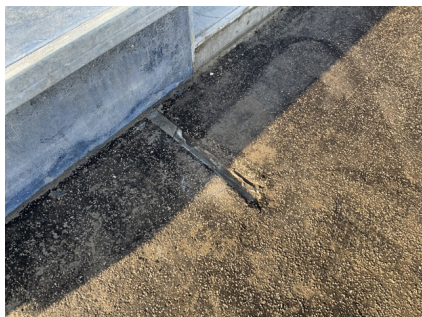
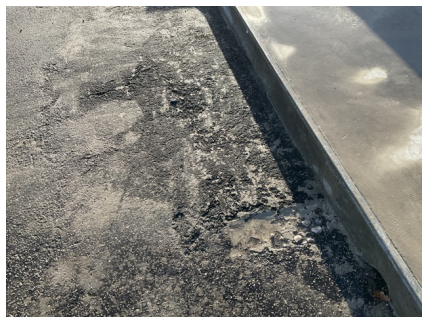
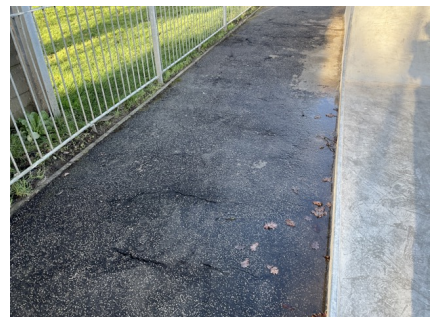
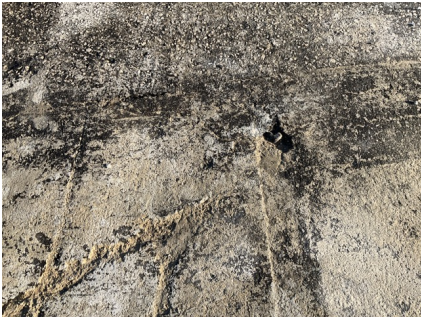
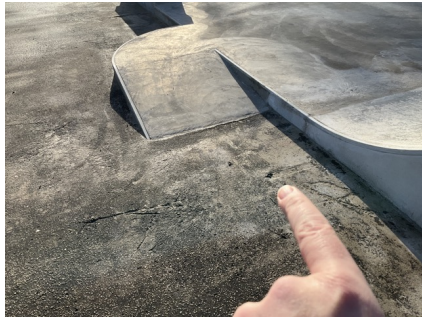
The surface is cracking.

Areas are cracking / cracked around the perimeter of the skate park. Repair.
Metal rod is exposed in front of the curved path. Repair.

Repair.

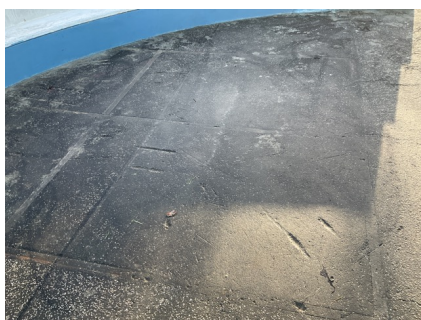
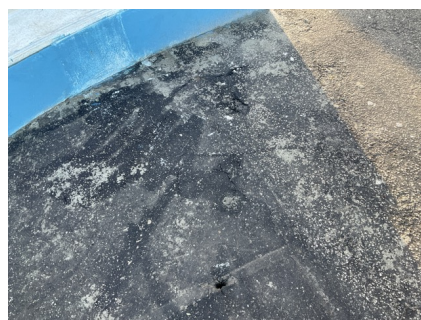
The surface is cracking.

Surface is cracking and damaged in areas around steps. Repair.

Low

Read the notes for further action.

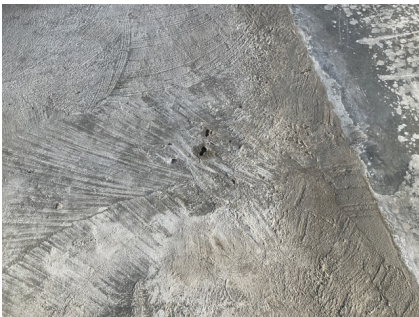
The surface is cracking.

Small holes at the transition near the curved path entrance.

Low

Read the notes for further action.
