# Safety Inspection Report

Annual Inspection

## Station Road Skatepark

24 June 2019

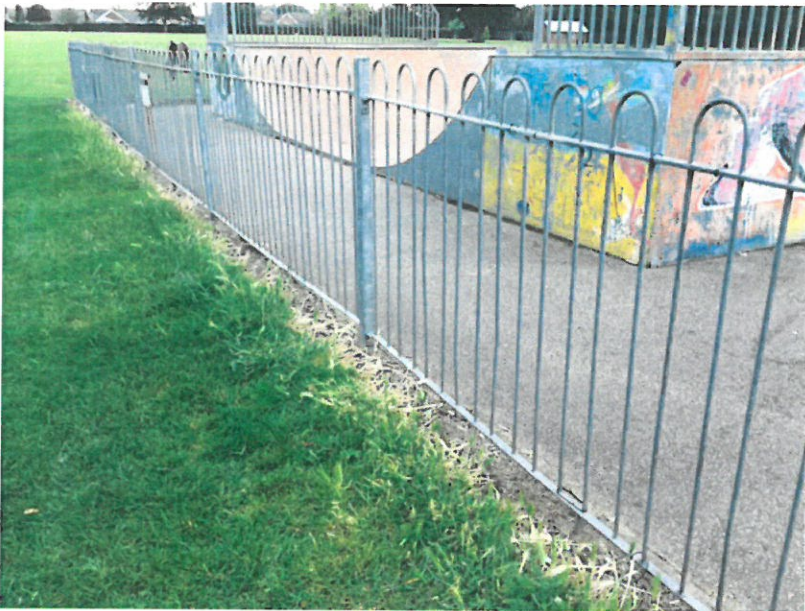
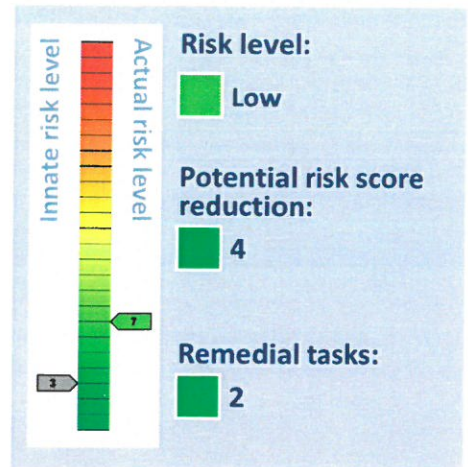
# Fencing

Hard or sharp projections.

Two end posts have gate fittings projecting - remove.

Remove hard, pointed and sharp projections.

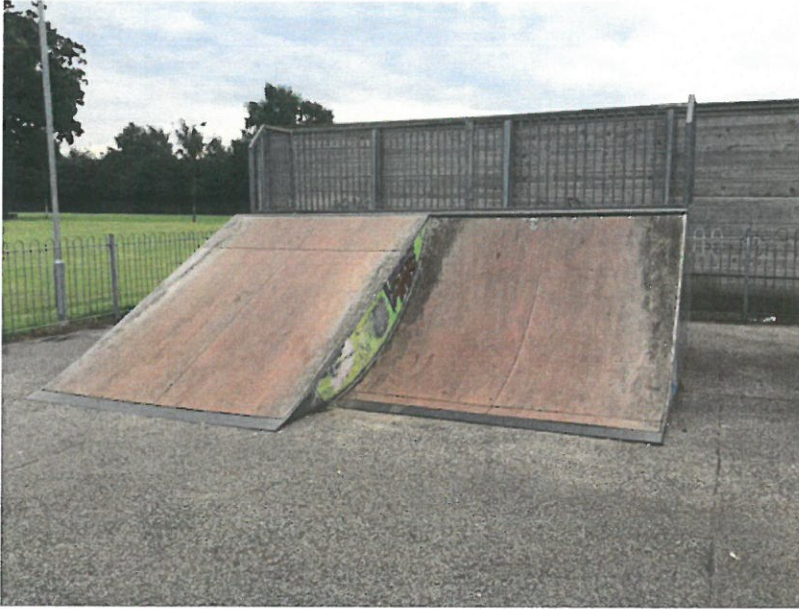
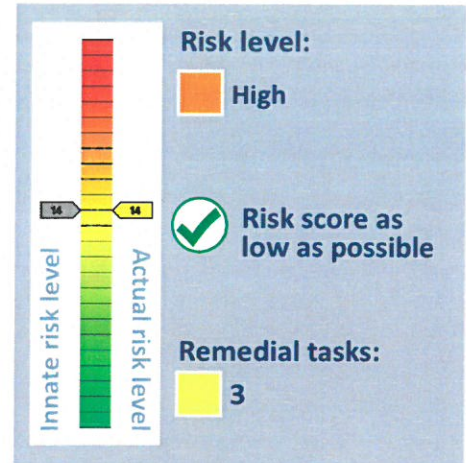
# Skate A - Combination Flat Ramp & Quarter Pipe (1500 mm)

Some damage to the Skatelite riding surface - monitor.

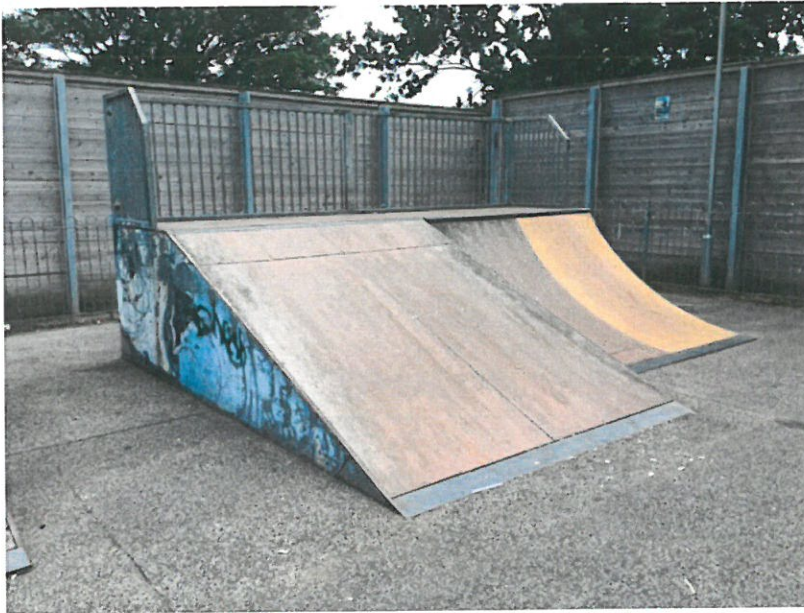
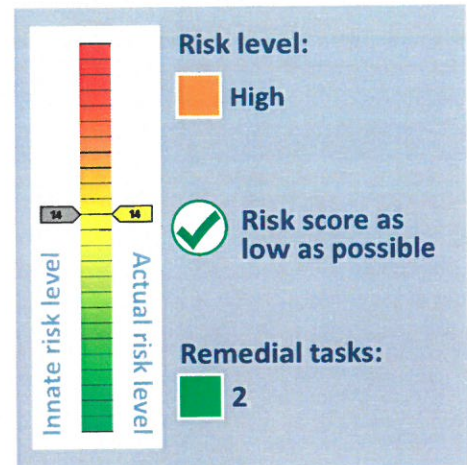
# Skate B - Combination Flat Ramp & Quarter Pipe

EN 14974:2019  
The item or its surfacing are not compliant with the requirements of the relevant standards.

Foot plate sinking into the tarmac. Large ridge - repair.

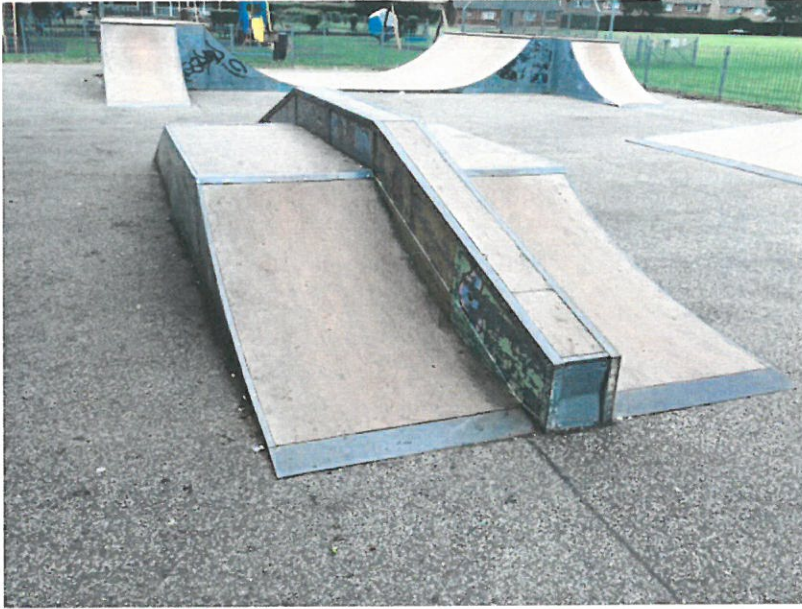
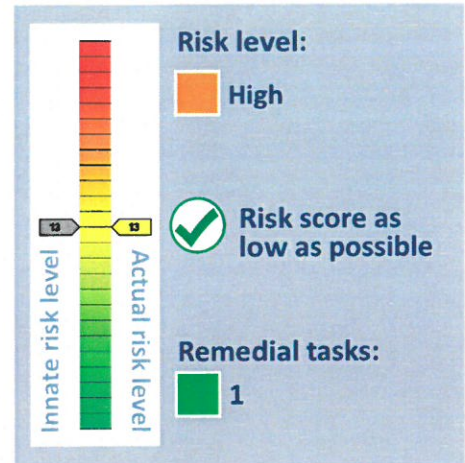
# Skate - Driveway - With Grind Box (In Middle)

The foot plate is sinking into the tarmac - repair.

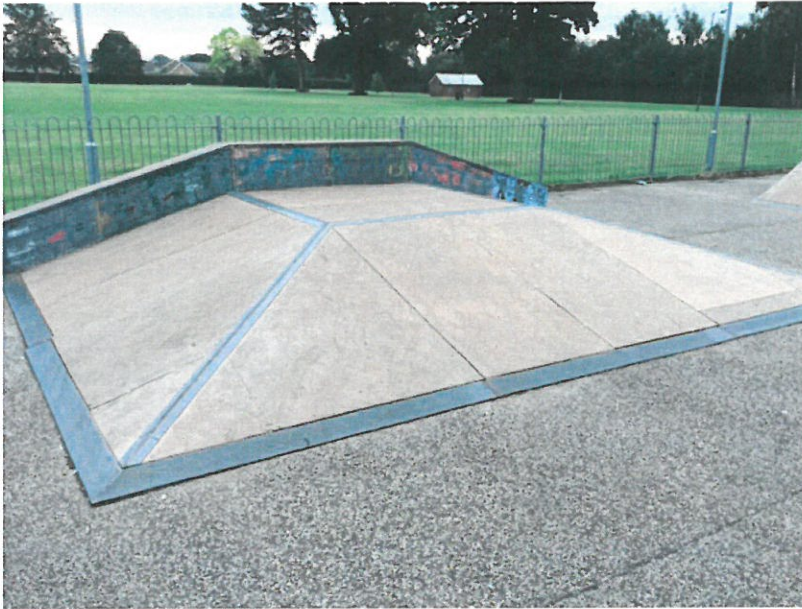
# Skate - Pyramid Driveway - With Grind Box

**Risk level:**  
High

Rivets are missing.

Riding surface metalwork lifting due to damaged rivets - repair.

Item is damaged.

Skatelite damaged - replace.

Tarmac uneven - repair.

The foot plate is sinking into the tarmac - repair.

Replace.

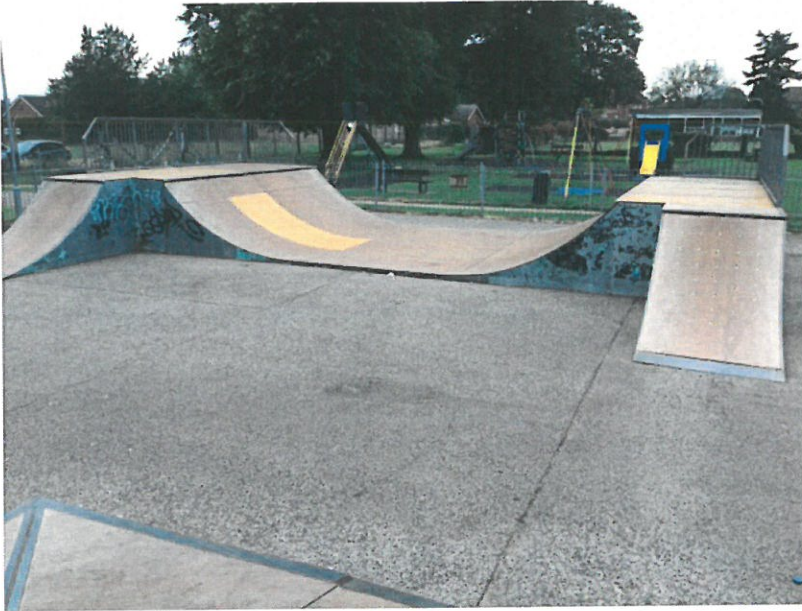
# Skate - Half Pipe - With 2 Hips

**Risk level:**  
High

Rivets are missing.

The riding surface is lifting due to damaged rivets - repair.

Item edges are worn.

Timber delaminating and damaged.

The foot plate is sinking into the tarmac - repair.

Replace.
